**Flood Control Project Maintenance
Levee Inspections**
LMA District Cover Sheet
Spring 2017 Levee Inspection Results

Reclamation District No. 0765 Glide

Spring 2017 Levee Inspection Results

Waterway			Bank	Unit Miles
Unit No. 01 Sacramento River			Right	1.72
	Spring (March - May)	Summer (June - August)	(September - November) Fall	Winter (December - February)
Unit Maintenance Rating (Fall Only)				
Date of Inspection	3/13/2017 - 3/13/2017			
DWR Inspector	Richard Willoughby			
Accompanied By	Everett Lovejoy RD 765

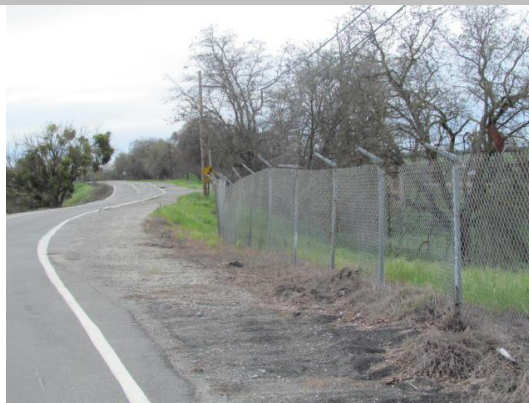
Photo 1 of 1 : SP_2017_RD0765_211_12_20170313_00013.jpg

Looking southwest at fence along landward shoulder.

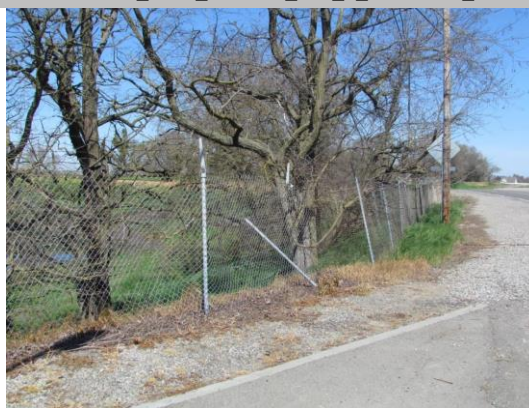
Photo 1 of 3 : SP_2017_RD0765_211_3_20170314_00079.jpg

LM Start	0.05	Rating **	U	Issue No.	3
LM End	0.05	Issue Type +	Ma	Location *	LS
Category	Earthen Levee			GPS Latitude/Longitude	
				Start	End
Item	Trim / Thin Trees			38.502253 °	38.502253 °
				-121.560192 °	-121.560192 °
DWR ID	DWR_RD0765_01_s_2012_3				
Comment Code					
T1 : Trim trees to at least five feet above ground level.					
Inspector Comment					
Trees blocking view of landward slope.

Looking north at untrimmed trees along landward slope. (Spring 2017)

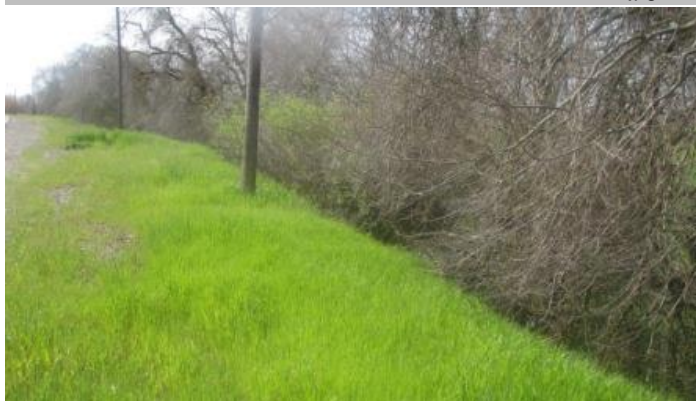
Photo 1 of 2 : SP_2017_RD0765_211_28_20170313_00024.jpg

Looking downstream (south) at trees on landside slope & toe.

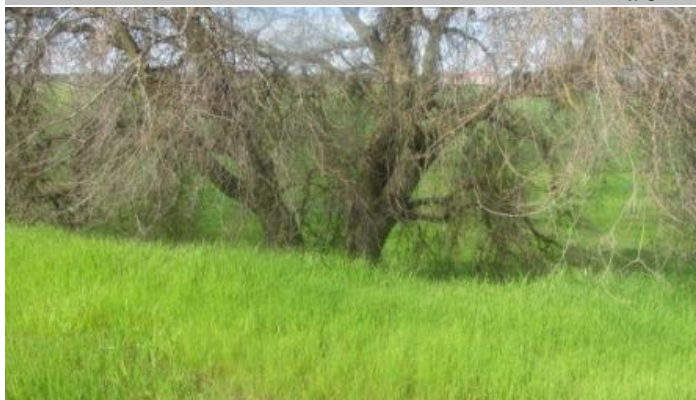
Photo 2 of 2 : SP_2017_RD0765_211_28_20170313_00025.jpg

Looking west at trees on landside toe.

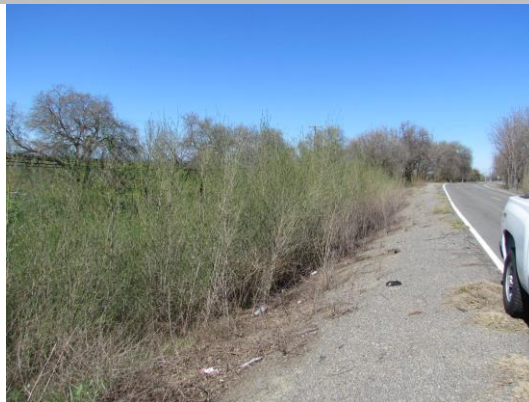
Photo 1 of 2 : SP_2017_RD0765_211_47_20170314_00082.jpg

Looking north at dense willows on landward slope. (Spring 2017)

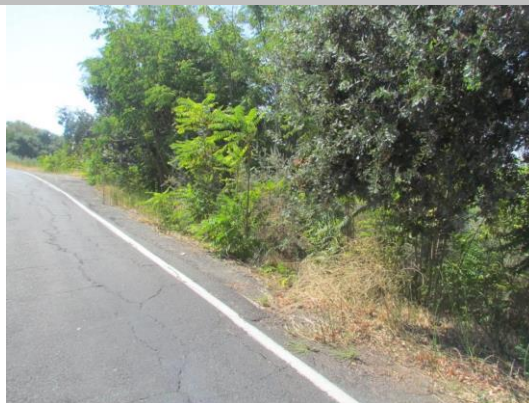
Photo 2 of 2 : SP_2017_RD0765_211_47_20170313_00039.jpg

Looking southwest at dense vegetation on landward shoulder and slope. (Fall 2016)

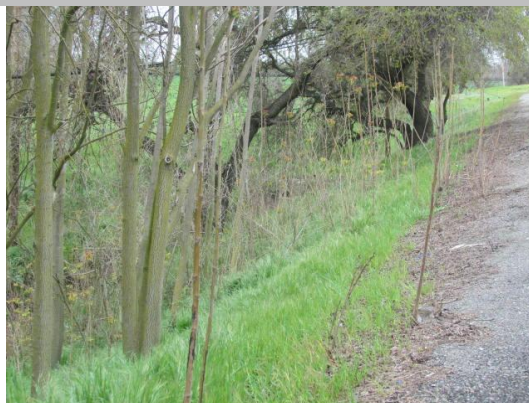
Photo 1 of 2 : SP_2017_RD0765_211_32_20170313_00029.jpg

Looking northwest at trees (saplings) on landward slope.

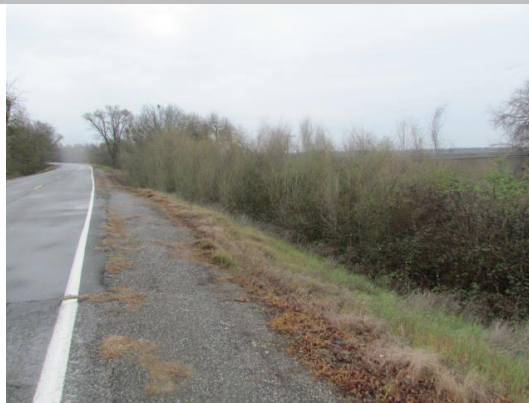
Photo 2 of 2 : SP_2017_RD0765_211_32_20170313_00030.jpg

Looking southwest at dense vegetation on landside slope and toe. (2015)

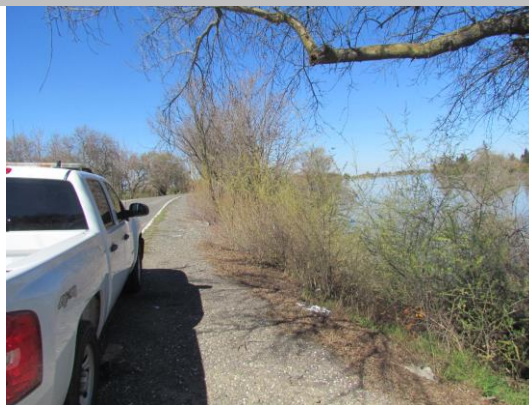
Photo 2 of 4 : SP_2017_RD0765_211_24_20170314_00084.jpg

Looking north at willows and other veg. on waterward slope. (Spring 2017)

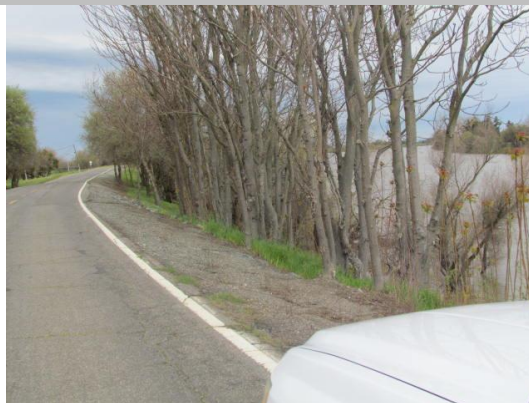
Photo 4 of 4 : SP_2017_RD0765_211_24_20170313_00021.jpg

Looking northeast at cluster of trees on waterward slope. (Spring 2016)

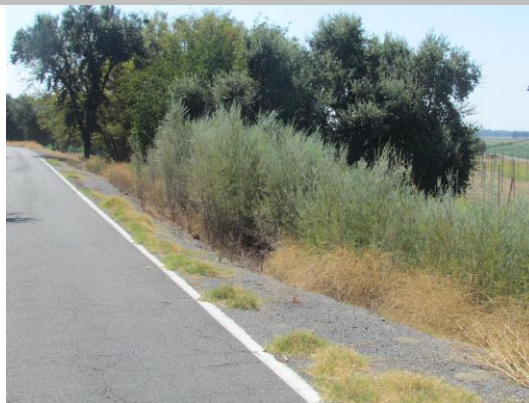
Photo 1 of 2 : SP_2017_RD0765_211_59_20170313_00059.jpg

Looking northwest at dense vegetation on landward slope. (Fall 2016)

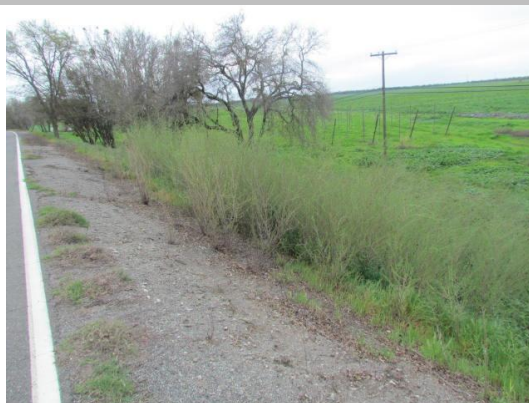
Photo 2 of 2 : SP_2017_RD0765_211_59_20170313_00060.jpg

Looking northwest at dense vegetation on landward slope. (Spring 2016)

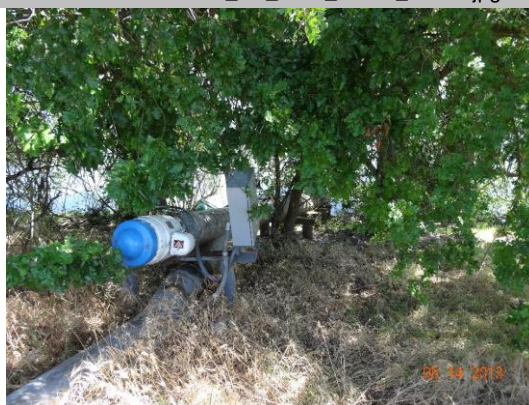
Photo 1 of 3 : UCIP_SP_2017_44403_60815.jpg

Comment Code					
Inspector Comment					
FS_ID:44403 DS_ID:21138 EP_NO: 3314 Repair Type: Non-Urgent Crossing Status: Found UCIP Comments: Dense vegetation limit's the ability to determine condition of landward slope for potential leaks associated with crossing. Recommend having owner clear slope to be able to properly inspect slopes for leaks. FIELD_STRUCT_DESC: 16-inch steel pipe hthrough the levee, 4.0 feet below the crown. Cutoff wall around pipe at center of levee. Slant pump on the waterward slope, with 22-inch inlet pipe extending from channel. 16-inch pipe connects to 12-inch steel pipe at landward shoulder, extending to concrete standpipe discharge outlet at the toe. Cobble revetment on waterward slope. (Permit No. 3314-1960) FS Date: 5/14/2013

View of waterward side--pipe, pump, control panels, and electrical conduit.

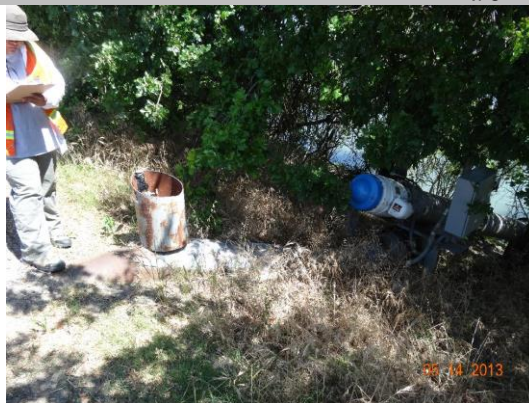
Photo 2 of 3 : UCIP_SP_2017_44403_60814.jpg

Siphon breaker encased in steel casing located on waterward side.

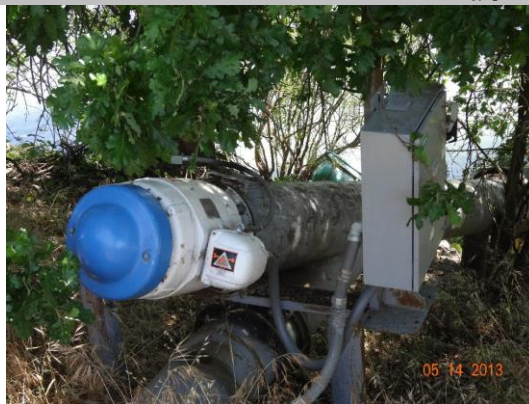
Photo 3 of 3 : UCIP_SP_2017_44403_60813.jpg

Close up of slant pump and control panel on waterward side.

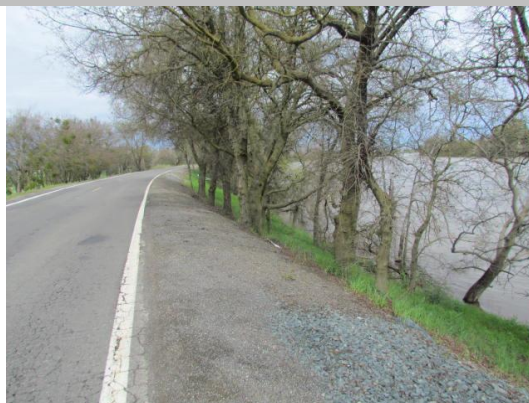
Photo 1 of 1 : SP_2017_RD0765_211_10_20170313_00011.jpg

Looking northeast at trees on waterward slope.

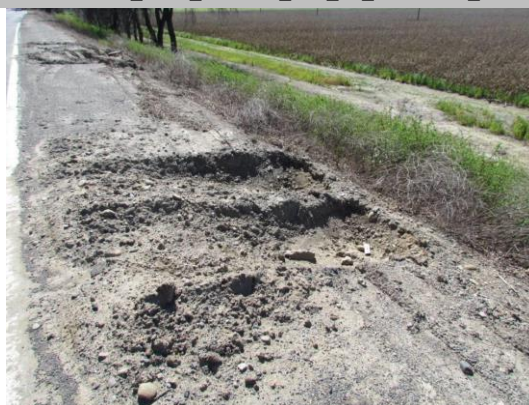
Photo 1 of 2 : SP_2017_RD0765_211_68_20170314_00085.jpg

LM Start	0.75	Rating **	M	Issue No.	68
LM End	0.75	Issue Type +	Ma	Location *	LS
Category	Earthen Levee			GPS Latitude/Longitude	
				Start	End
Item	Slope Stability			38.492705 °	38.492705 °
				-121.557193 °	-121.557193 °
DWR ID	DWR_RD0765_01_s_2017_68				
Comment Code					
S3 : Repair the levee slope damaged by vehicle traffic and prevent access where possible.					
Inspector Comment					
Damage cause by truck.

Looking south at levee damage caused by vehicle traffic. (Spring 2017)

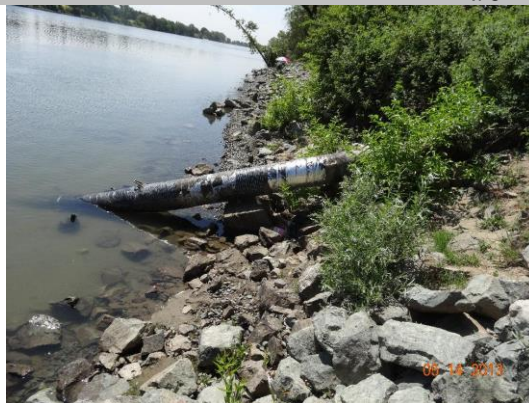
Photo 1 of 3 : UCIP_SP_2017_44404_60819.jpg

LM Start	0.95	Rating **	M	Issue No.	70
LM End	0.95	Issue Type +	En	Location *	LS
Category	Supplemental			GPS Latitude/Longitude	
				Start	End
Item	DWR UCIP Field Study			38.490192 °	38.490192 °
				-121.555628 °	-121.555628 °
DWR ID					
Comment Code					
Inspector Comment					
FS_ID:44404 DS_ID:21139 EP_NO: 653 Repair Type: Non-Urgent Crossing Status: Found UCIP Comments: Dense vegetation on landward side limits visual inspection of potential leaks. Recommend clearing slope of vegetation. FIELD_STRUCT_DESC: 16-inch steel pipe through the levee, 14.3 feet below the crown. Pump on the landward side. Gate valve on the waterward slope. (USACE-1959). This entry matches the Drainage or Irrigation Structure referenced in O&M manual (RM 50.29). FS Date: 5/14/2013

Pipe section visible at waterward toe.

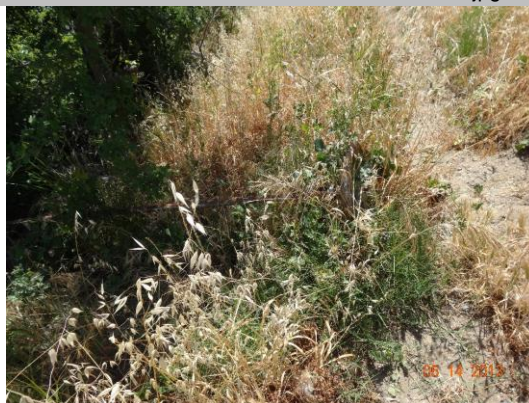
Photo 2 of 3 : UCIP_SP_2017_44404_60818.jpg

View of waterward side--dense vegetation limits inspection.

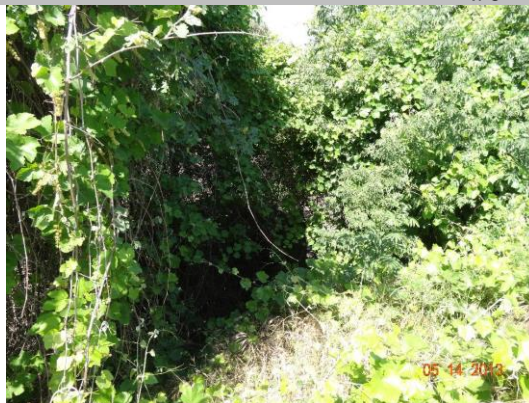
Photo 3 of 3 : UCIP_SP_2017_44404_60821.jpg

View of landward side--dense vegetation limits inspection.

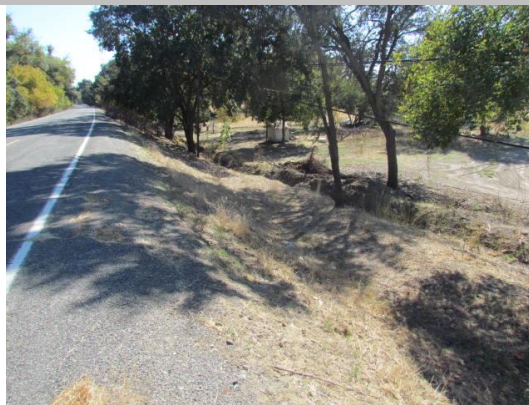
Photo 1 of 1 : SP_2017_RD0765_211_51_20170313_00044.jpg

Looking southwest at irrigation ditch on landward toe.

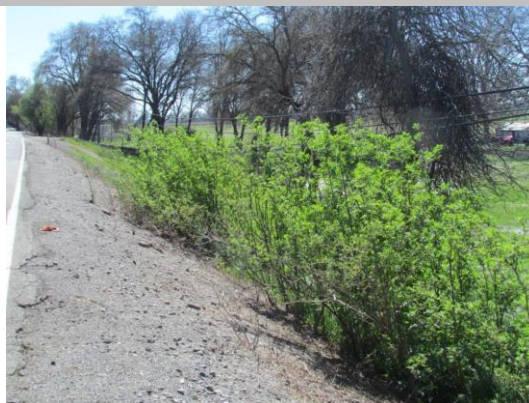
Photo 1 of 2 : SP_2017_RD0765_211_40_20170314_00089.jpg

Looking south at new growth on landward slope. (Spring 2017)

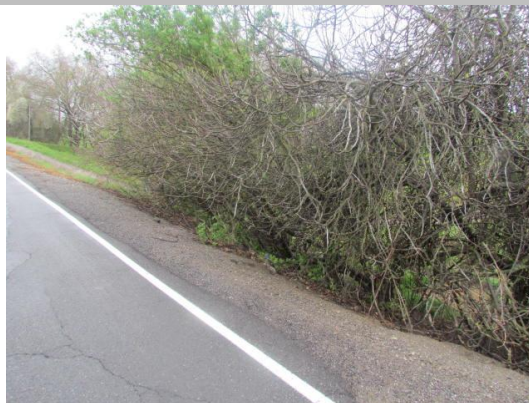
Photo 2 of 2 : SP_2017_RD0765_211_40_20170313_00037.jpg

Looking southwest at fig trees and other trees on landside slope and toe. (Fall 2016)

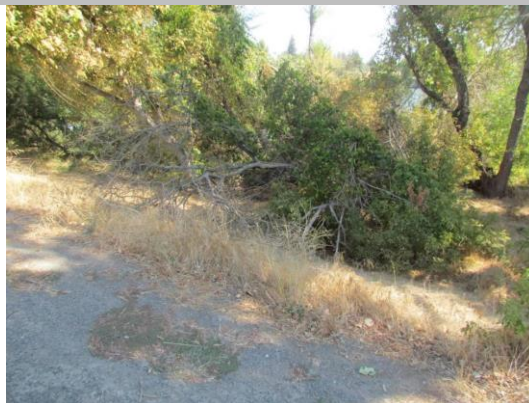
Photo 1 of 1 : SP_2017_RD0765_211_58_20170313_00058.jpg

Looking northeast at fallen tree on waterward slope.

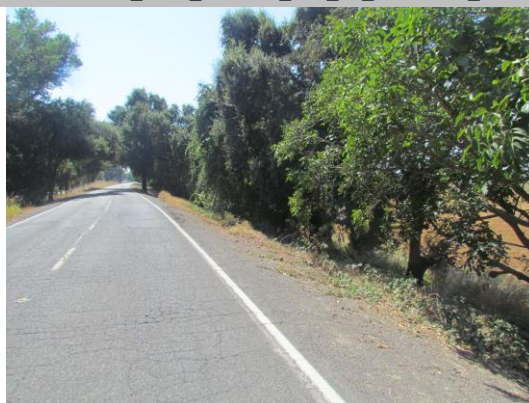
Photo 1 of 1 : SP_2017_RD0765_211_38_20170313_00034.jpg

Looking southwest at untrimmed trees on landward slope.

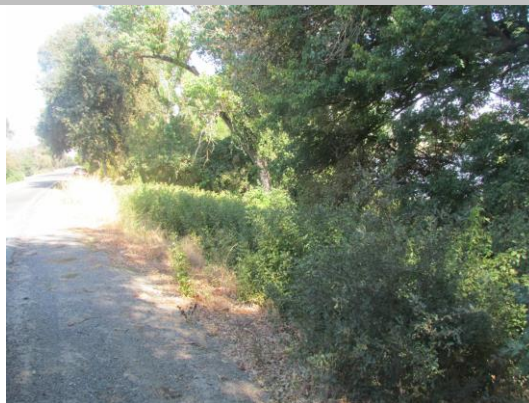
Photo 1 of 1 : SP_2017_RD0765_211_65_20170313_00066.jpg

Looking north at wildroses and untrimmed trees on waterward shoulder and slope.

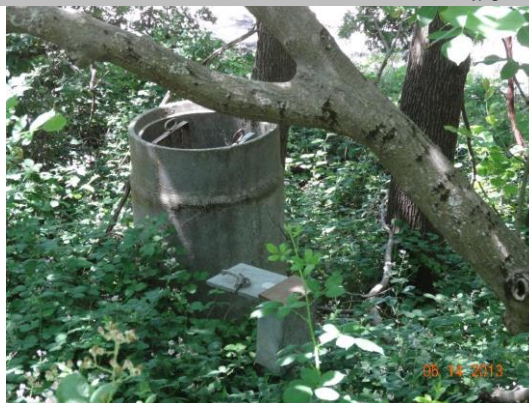
Photo 1 of 3 : UCIP_SP_2017_44407_73022.jpg

LM Start	1.12	Rating **	M	Issue No.	71
LM End	1.12	Issue Type +	En	Location *	WS
Category	Supplemental			GPS Latitude/Longitude	
				Start	End
Item	DWR UCIP Field Study			38.487917 °	38.487917 °
				-121.554405 °	-121.554405 °
DWR ID					
Comment Code					
Inspector Comment					
FS_ID:44407 DS_ID:21140 EP_NO: N/A Repair Type: Non-Urgent Crossing Status: Indicator Found UCIP Comments: Dense vegetation on waterward and landward slopes limit visual inspection of potential leaks along pipe alignment. Recommend having owner clear vegetation along slopes. FIELD_STRUCT_DESC: 6-inch steel pipe through the levee, 18.8 feet below the crown. Concrete standpipe on the LS toe. Pump on WS slope. This entry matches the Drainage or Irrigation Structure referenced in O&M manual (RM 50.15). FS Date: 4/9/2015

Overview of landward side--concrete standpipe and control panel located at toe.

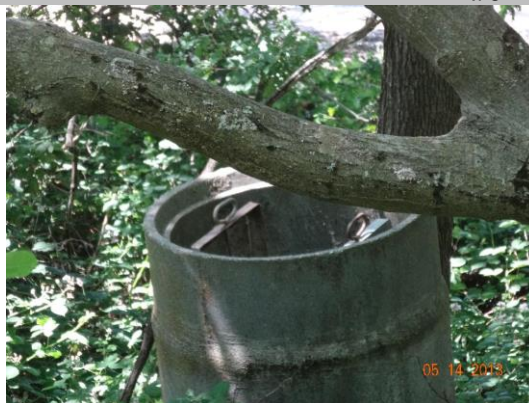
Photo 2 of 3 : UCIP_SP_2017_44407_73021.jpg

Concrete standpipe with 2 gates inside located on landward side.

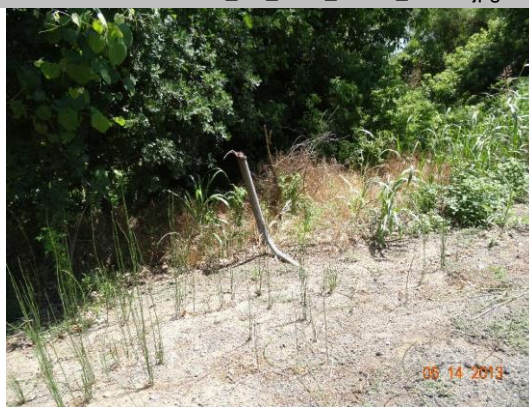
Photo 3 of 3 : UCIP_SP_2017_44407_73020.jpg

Conduits disconnected and damaged on waterward side.

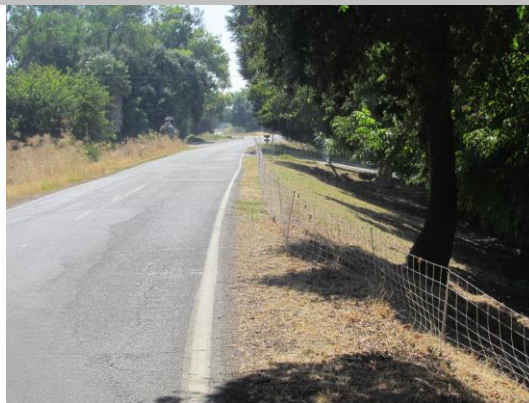
Photo 1 of 3 : SP_2017_RD0765_211_54_20170313_00046.jpg

Looking south at fencing for goats on landward slope. (Fall 2016)

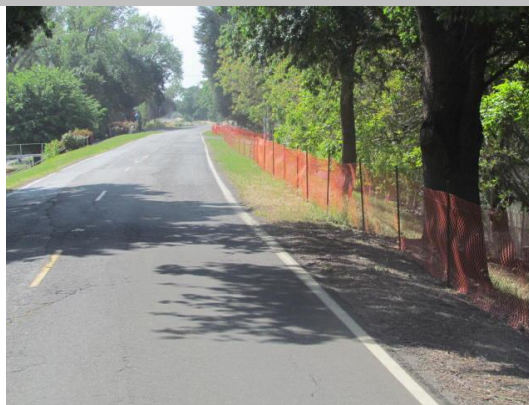
Photo 2 of 3 : SP_2017_RD0765_211_54_20170313_00047.jpg

Looking south at temporary fence on landward shoulder. (Spring 2016)

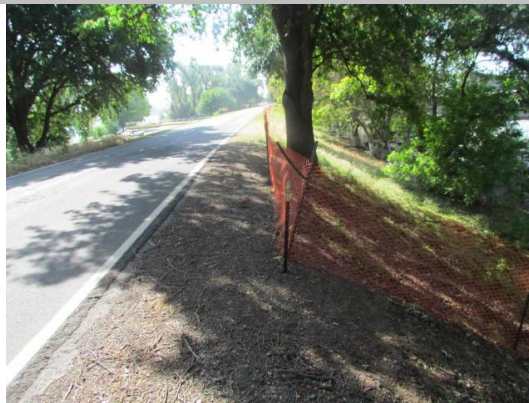
Photo 3 of 3 : SP_2017_RD0765_211_54_20170313_00048.jpg

Looking south at temporary fence on landward slope. (Spring 2016)

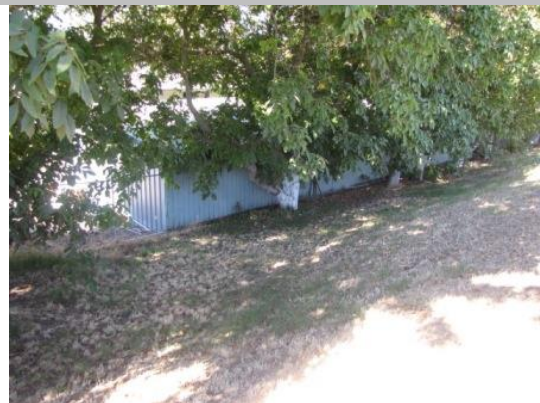
Photo 1 of 1 : SP_2017_RD0765_211_43_20170313_00038.jpg

Looking northwest at buildings along landside toe.

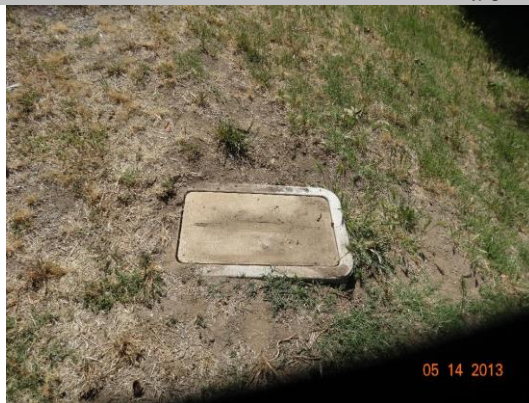
Photo 1 of 2 : UCIP_SP_2017_43203_71214.jpg

LM Start	1.20	Rating **	M	Issue No.	72
LM End	1.20	Issue Type +	En	Location *	LS
Category	Supplemental			GPS Latitude/Longitude	
				Start	End
Item	DWR UCIP Field Study			38.486830 °	38.486830 °
				-121.553698 °	-121.553698 °
DWR ID					
Comment Code					
Inspector Comment					
FS_ID:43203 DS_ID:24660 EP_NO: N/A Repair Type: Non-Urgent Crossing Status: Indicator Found UCIP Comments: Unable to confirm details of crossing. Need to contact owner to determine additional details about crossing and permit issued. FIELD_STRUCT_DESC: PG&E utility service box on landward shoulder. FS Date: 5/14/2013

Utility box located on landward side.

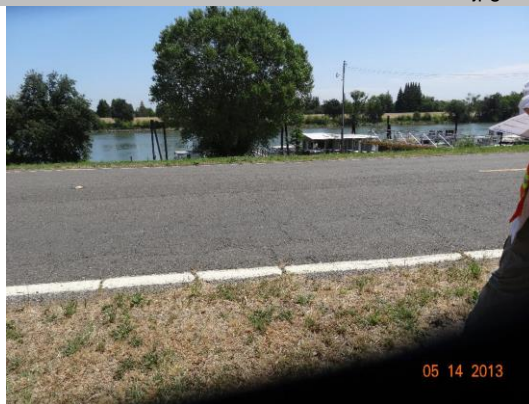
Photo 2 of 2 : UCIP_SP_2017_43203_71213.jpg

View of levee crown and waterward side.

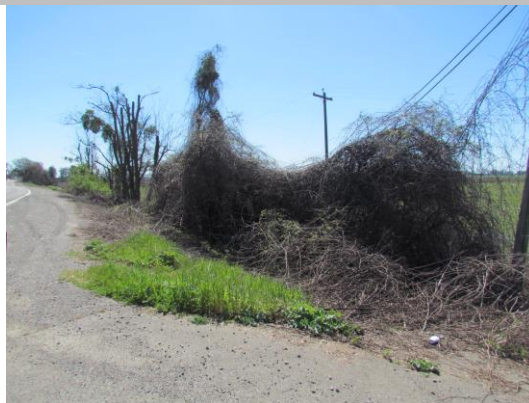
Photo 1 of 2 : SP_2017_RD0765_211_33_20170314_00090.jpg

Looking west at dead vines on landward slope. (Spring 2017)

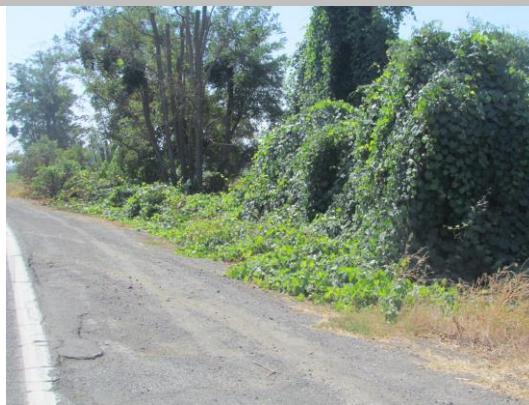
Photo 2 of 2 : SP_2017_RD0765_211_33_20170313_00031.jpg

Looking west at dense vegetation (grapevines) on landward slope. (Fall 2016)

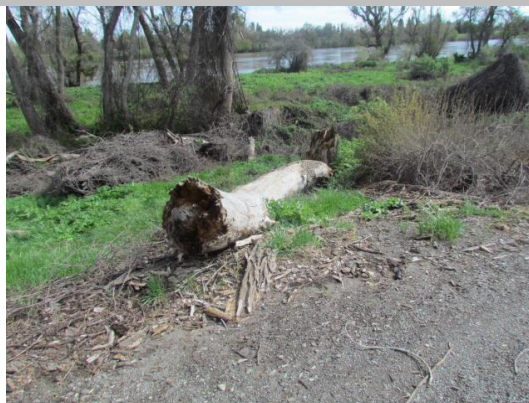
Photo 1 of 4 : SP_2017_RD0765_211_7_20170313_00007.jpg

Looking southeast at branch on waterward slope.

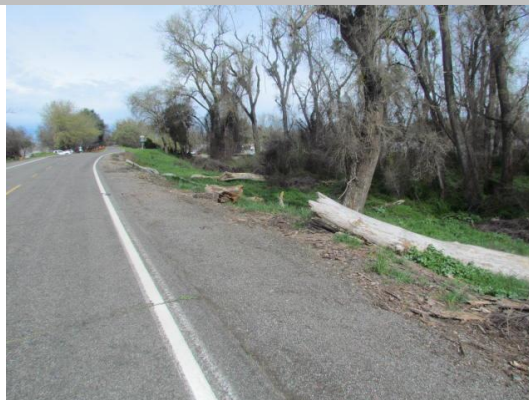
Photo 2 of 4 : SP_2017_RD0765_211_7_20170313_00008.jpg

Looking northeast at tree limbs on waterward slope.

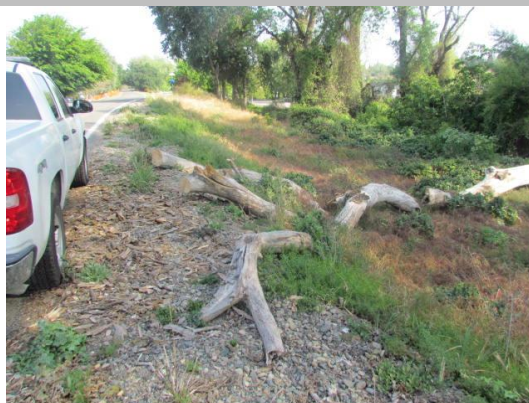
Photo 4 of 4 : SP_2017_RD0765_211_7_20170313_00010.jpg

Looking north at down tree across waterward slope.(2015)

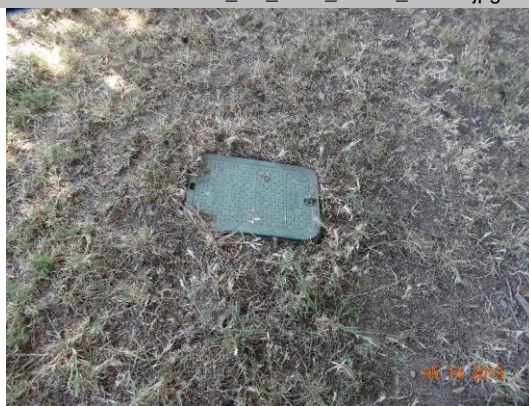
Photo 1 of 1 : UCIP_SP_2017_39022_71212.jpg

LM Start	1.37	Rating **	M	Issue No.	73
LM End	1.37	Issue Type +	En	Location *	WS
Category	Supplemental			GPS Latitude/Longitude	
				Start	End
Item	DWR UCIP Field Study			38.484656 °	38.484656 °
				-121.552362 °	-121.552362 °
DWR ID					
Comment Code					
Inspector Comment					
FS_ID:39022 DS_ID:24661 EP_NO: N/A Repair Type: Non-Urgent Crossing Status: Indicator Found UCIP Comments: Need to contact owner to determine if crossing goes through levee. FIELD_STRUCT_DESC: 3 inch irrigation line through levee at unknown depth. Service box located on landward shoulder. FS Date: 5/14/2013

Utility box located on landward shoulder.

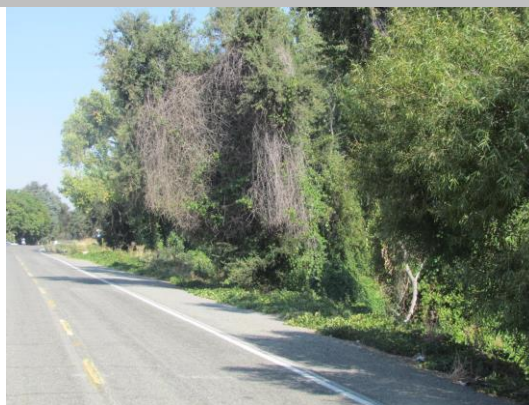
Photo 1 of 3 : SP_2017_RD0765_211_4_20170313_00003.jpg

Looking northeast at untrimmed trees and other vegetation on waterward slope. (Fall 2016)

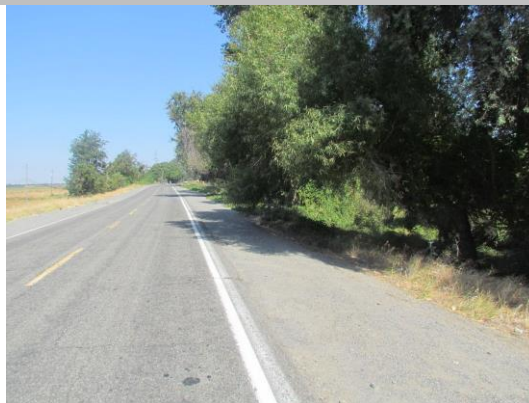
Photo 2 of 3 : SP_2017_RD0765_211_4_20170313_00004.jpg

Looking northeast at untrimmed trees on waterward slope. (Spring 2016)

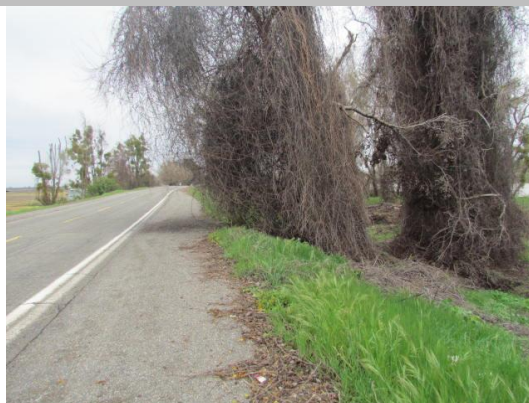
Photo 3 of 3 : SP_2017_RD0765_211_4_20170313_00005.jpg

Looking north at untrimmed trees on waterward slope. (Spring 2016)

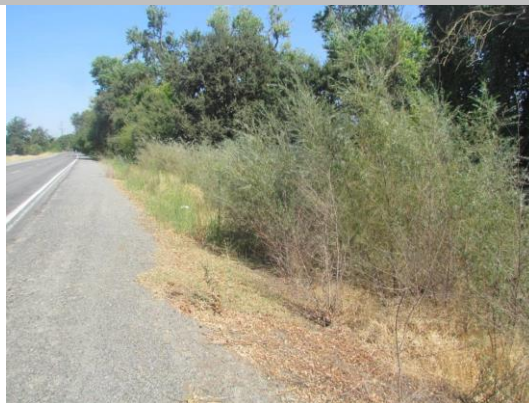
Photo 1 of 1 : SP_2017_RD0765_211_5_20170313_00006.jpg

Looking northwest at willows on waterward slope.

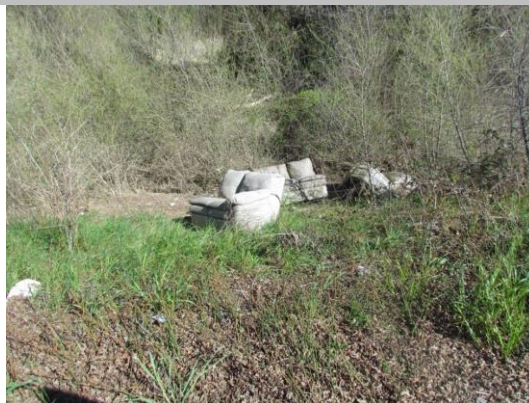
Photo 1 of 1 : SP_2017_RD0765_211_67_20170314_00091.jpg

Looking east at sofa on waterward slope.

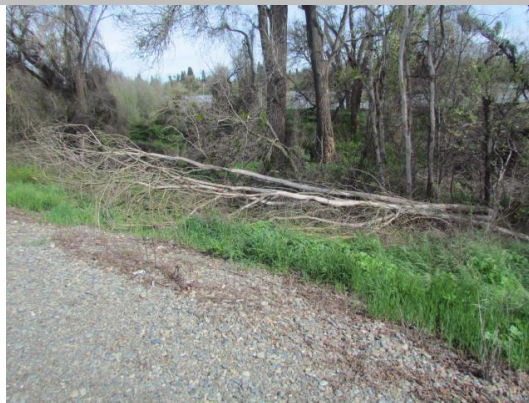
Photo 1 of 1 : SP_2017_RD0765_211_64_20170313_00065.jpg

Looking at fallen tree on waterward slope and toe.

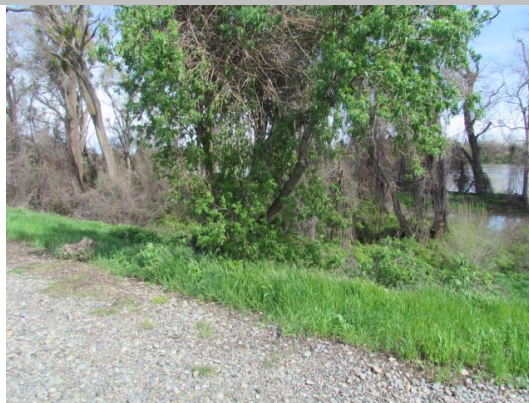
Photo 1 of 1 : SP_2017_RD0765_211_50_20170313_00043.jpg

Looking east at untrimmed tree on waterward slope.

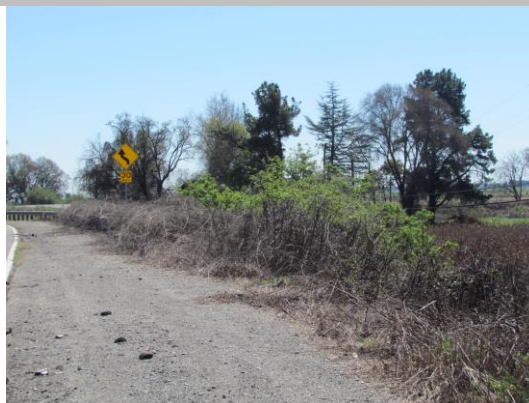
Photo 1 of 4 : SP_2017_RD0765_211_29_20170314_00092.jpg

Looking southwest at dead vines and other veg on landward slope.
(Spring 2017)

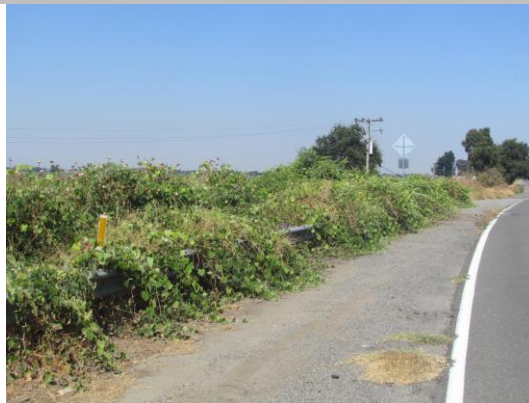
Photo 2 of 4 : SP_2017_RD0765_211_29_20170313_00026.jpg

Looking northwest at berryvines on landward slope and toe. (Fall 2016)

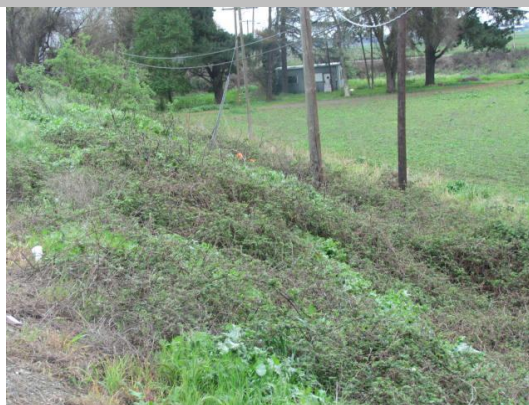
Photo 4 of 4 : SP_2017_RD0765_211_29_20170313_00028.jpg

Looking southwest at ground cover on landward slope. (Spring 2016)

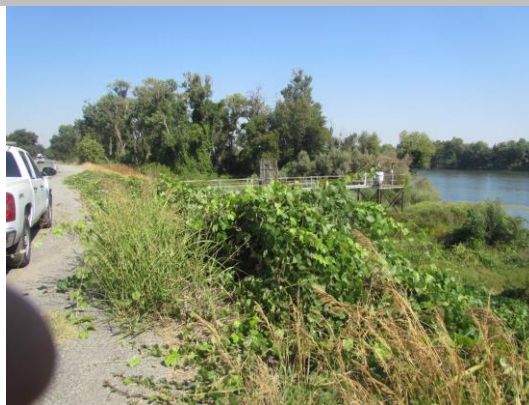
Photo 2 of 2 : SP_2017_RD0765_211_48_20170313_00040.jpg

Looking northeast at vines on waterward slope. (Fall 2016)

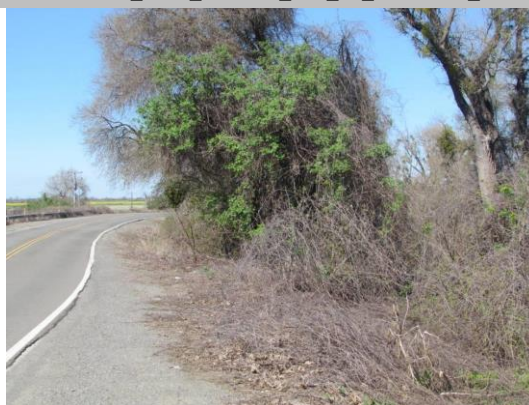
Photo 1 of 2 : SP_2017_RD0765_211_53_20170314_00095.jpg

Looking north at dense untrimmed trees on waterward slope. (Spring 2017)

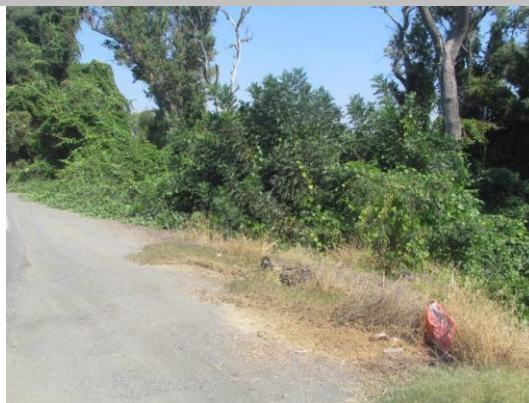
Photo 2 of 2 : SP_2017_RD0765_211_53_20170313_00045.jpg

Looking north at dense vegetation on waterward slope. (Fall 2016)
